Manhole Inspection Summary

Manhole # S29YY_023MH

Location Address: **3300 KESWICK RD**

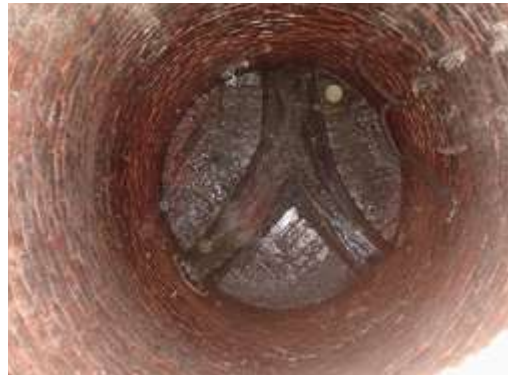
Top View

Corroded and missing steps. Bench debris.

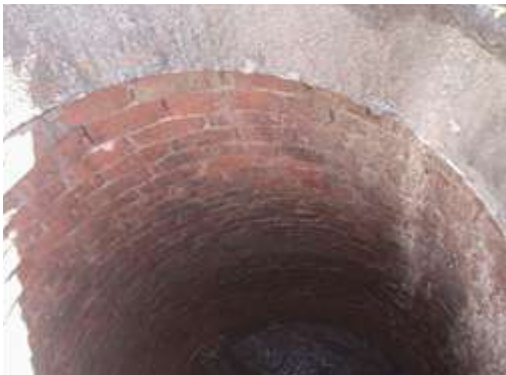
Defect

Frame leaks. Adjustment deterioration and infiltration. Corbel infiltration - other side.

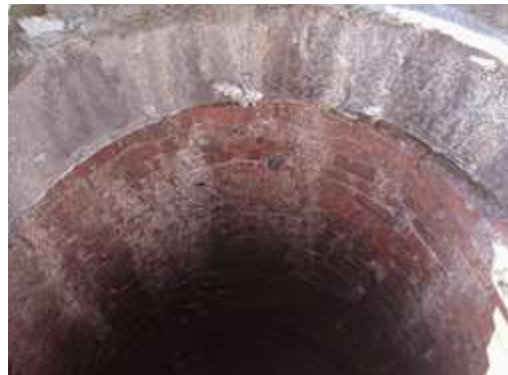
Defect

Frame leaks. Adjustment deterioration and infiltration. Corbel infiltration.

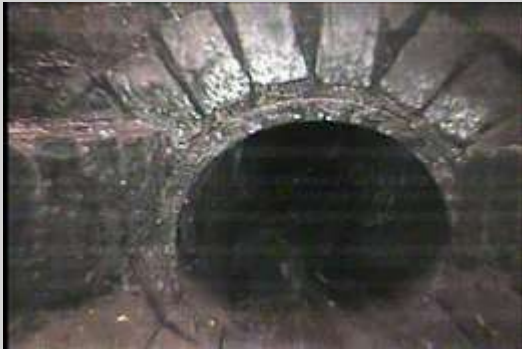
8 in. Circular Gravity Sewer Pipe Out @ 12 O'Clock

Pipe Material: **Clay** ☐ Pipe Lined

Invert Depth: **10.80** (ft.) Flow Characteristics: **Fast**

Deposits: ☒ None ☐ **Mud** ☐ Sludge ☐ **Debris** ☐ Grease

Infiltration: **None** Pipe Seal Cond: **Unknown**

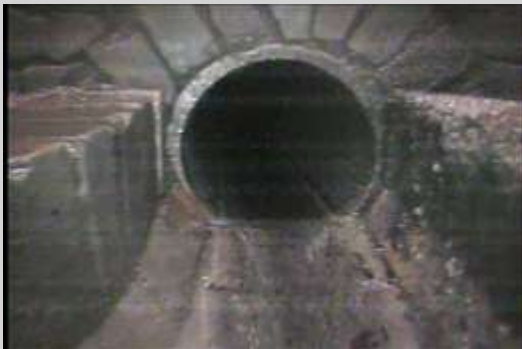
8 in. Circular Gravity Sewer Pipe In @ 5 O'Clock

Pipe Material: **Clay** ☐ Pipe Lined

Invert Depth: **10.30** (ft.) Flow Characteristics: **Fast**

Deposits: ☒ None ☐ **Mud** ☐ Sludge ☐ **Debris** ☐ Grease

Infiltration: **None** Pipe Seal Cond: **Unknown**

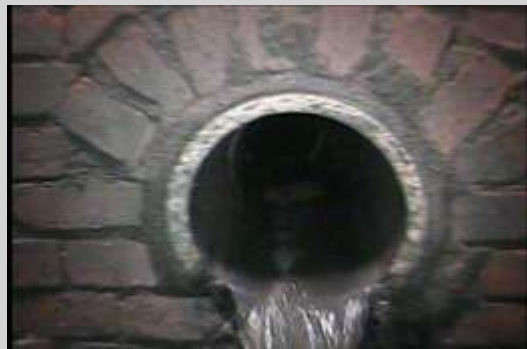
Pipe In @ 7 O'Clock

Deposits: ☐ None ☒ **Mud** ☐ Sludge ☒ **Debris** ☐ Grease

Silt Depth: **0.5** (in.)

Deposits Extent: **Light**
